**ENERGY SURVEY OF  
EISENHOWER ARMY MEDICAL CENTER  
FORT GORDON**

**AUGUSTA, GEORGIA**

**NARRATIVE REPORT**

**DECEMBER 23, 1996**

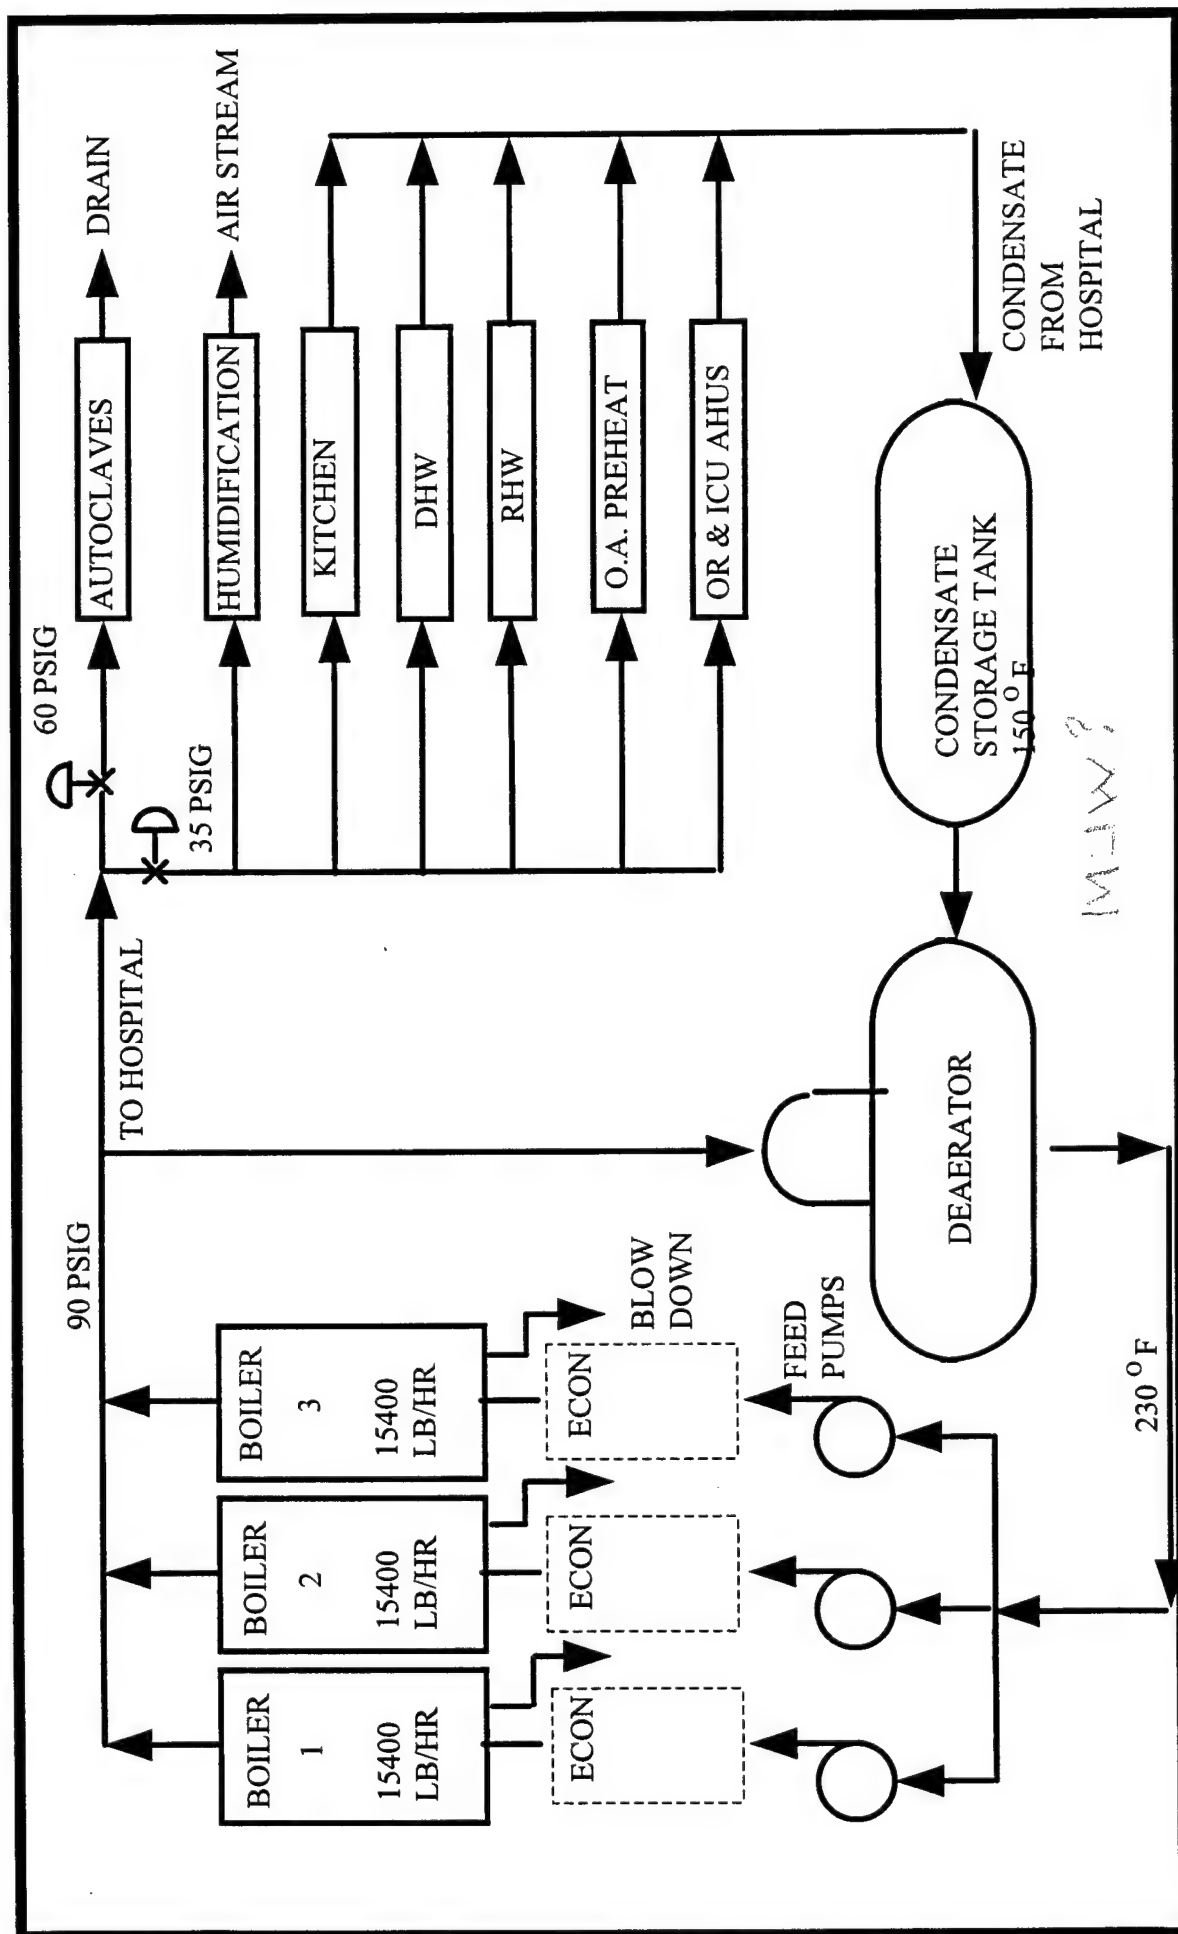
Figure 2.2-3

The boilers now operate at 75-90 psig supplying steam to the hospital (see Hospital Loads below for steam uses); and to the adjacent barracks for space heating and domestic hot water. Condensate from both locations is returned. Natural gas is used almost exclusively. Typically, only one boiler is needed to meet loads. The peak winter demand has never required more than two boilers. This was confirmed when we reviewed the boiler operating logs. Figure 2.2-4, which was generated from boiler log data, shows that only in the coldest weather would more than one boiler be required.

The boilers appear to be in generally good condition. The boiler area was clean and neat. The operators reported that during a recent boiler shutdown, the boiler tubes were visually inspected internally and found to be in good condition. There has never been a tube leak in any of the boilers.

We did, however, note many problems with boiler operation. The boiler steam pressure is changing rapidly (spiking) resulting in sudden demand for, or reduction of, steam flow. The magnitude of the steam flow change can be as much as 40 percent of boiler capacity. The frequency of these episodes are as often as four to six times per hour and continue around the clock. (On a survey trip in June 1996, cycles with periods of 40 seconds were observed.) A review of past boiler recorder charts reveal that this phenomena has been occurring for many months. This continual spiking is causing drum level swings that can become nearly unmanageable. Often, the operator must put another boiler into service to dampen the swings to regain control of the drum level. The air flow and fuel flow are swinging with each spike.

Operators report carryover problems. The exact cause is not determinable due to the severe cycling of the boilers. There appears to be steam regulation problems with 35 psi pressure reducing valves in the hospital. They may not be properly controlling the pressure in the 35 psi header system. The safety valve in that system is set at 46 psig and often pops to relieve excess pressure. That problem, coupled with the poor state of the boiler controls, makes it very difficult to determine the extent to which either is contributing to the carryover.

All boilers and associated controls are to be replaced as part of the FY96 Renovation Project.

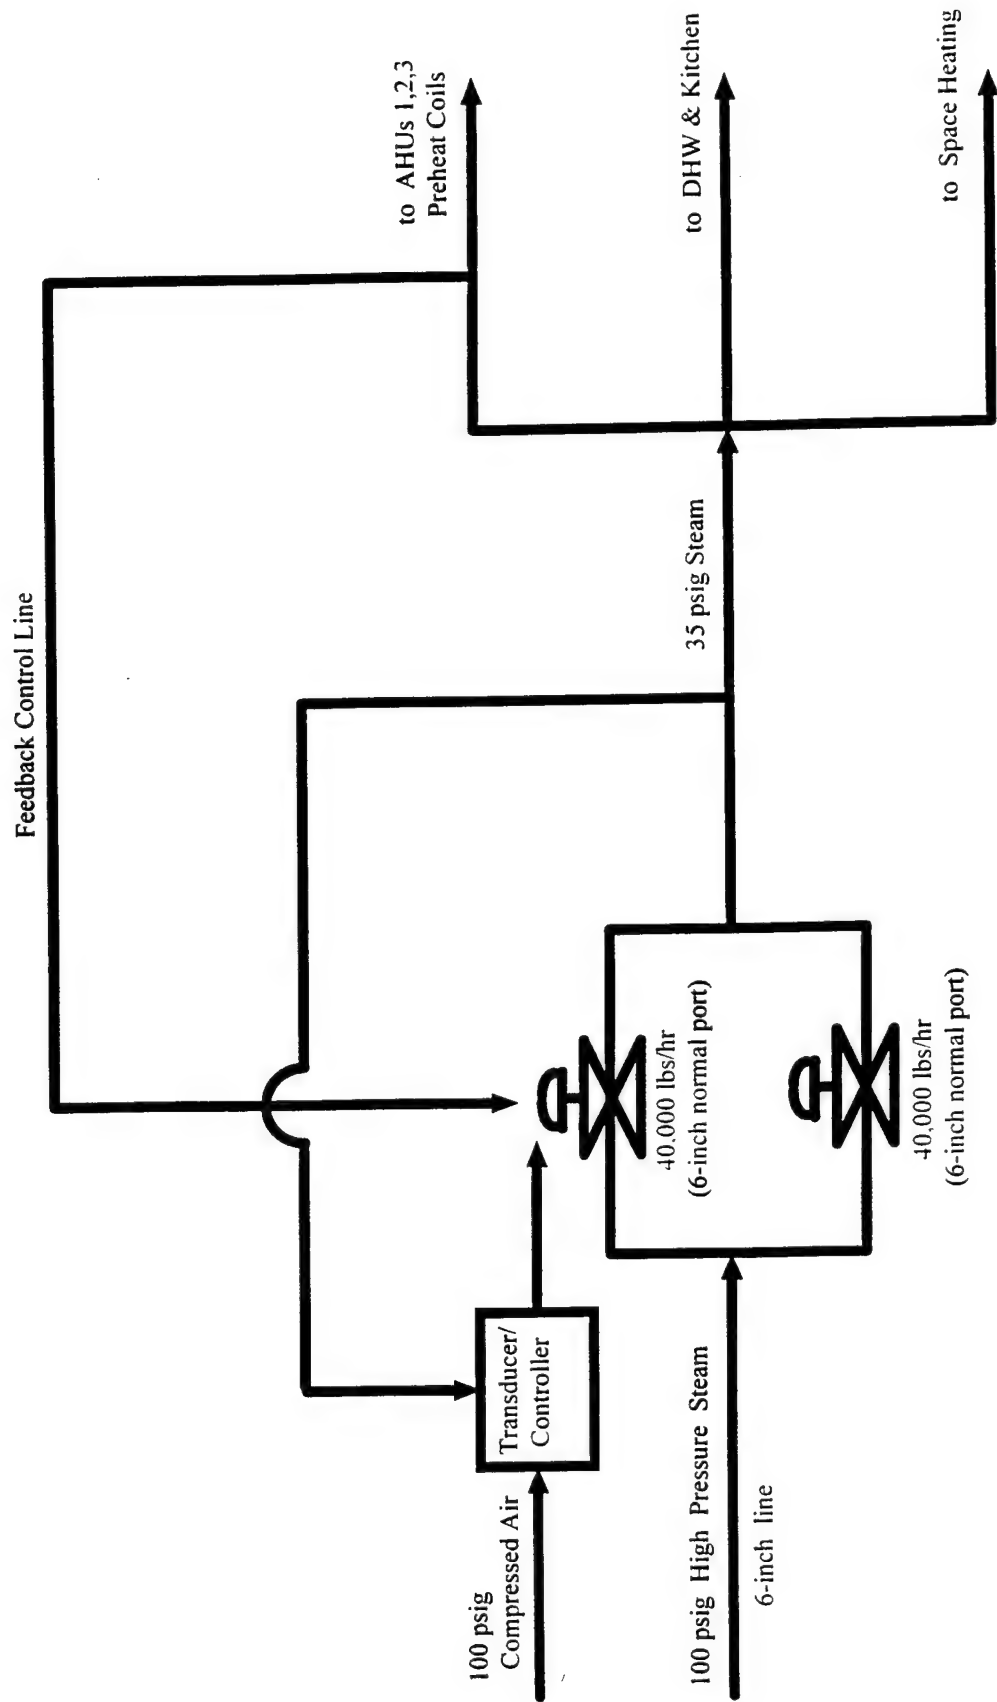
Another survey trip and test was conducted on August 13, 1996 to verify that the cycling was due to the controls and not hospital loads. The sensitivity of the controller was decreased and the effects observed. The steam flow chart for that day is shown in Figure 4.3-7. The adjustments decreased the magnitude of the fluctuations to about 1500 lbs/hr with a frequency of six cycles per hour. This confirmed that the controls are a major contributor to the cycling problem. A review of the PRV piping layout and controls revealed several problems.

Figure 4.3-8 Hospital Low Pressure Steam Pressure Regulating Value Station - Current Configuration  
 ( both valves are controlled with the same signals - only one is shown here )

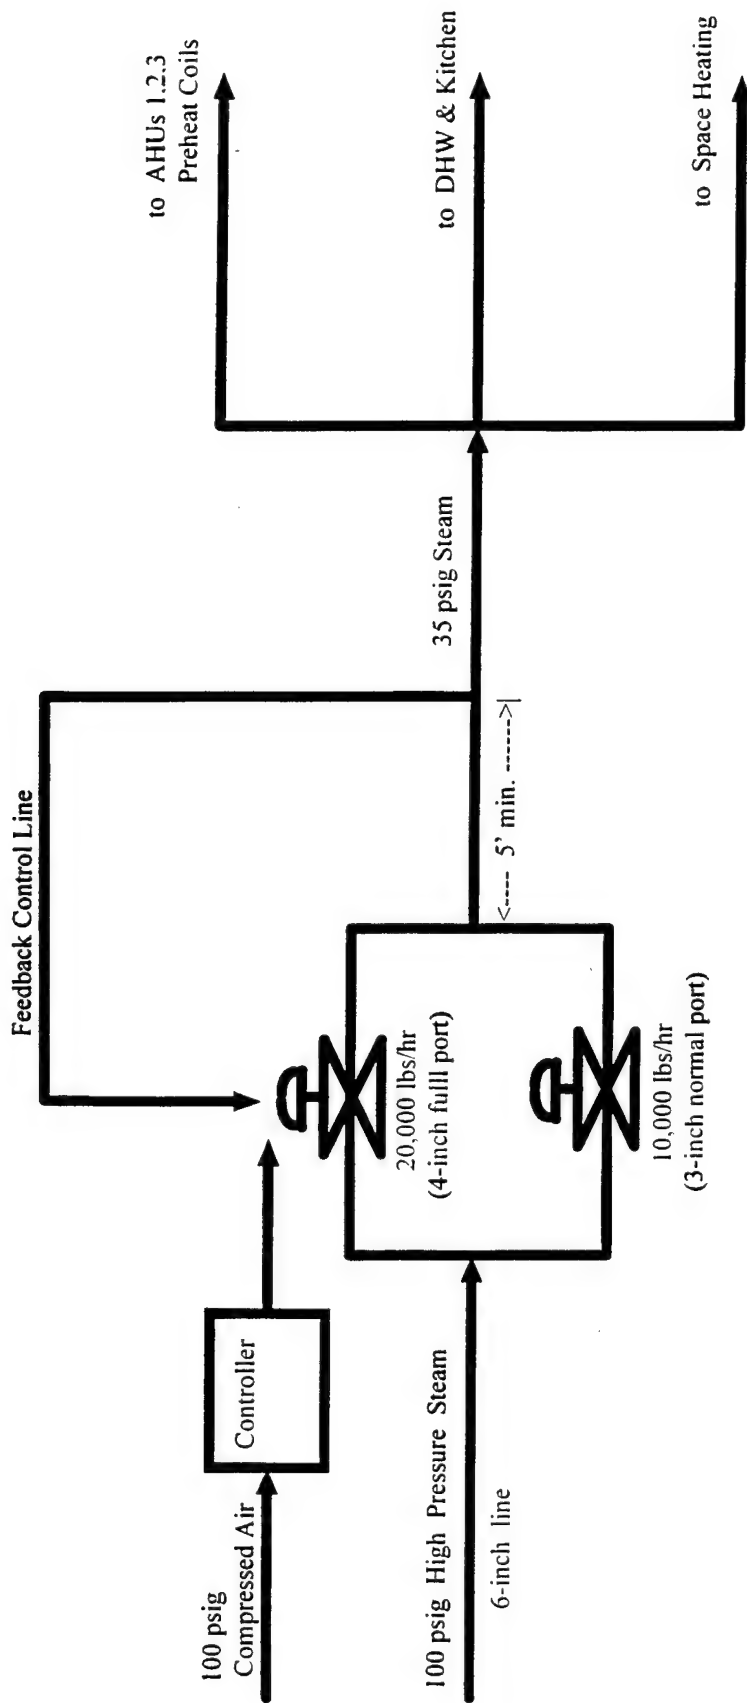
Figure 4.3-9 Hospital Low Pressure Steam Pressure Regulating Value Station - Proposed Configuration  
( the smaller valve leads in a lead/lag operation)

The proposed design is shown in Figure 4.3-9. The feedback signal should be relocated immediately downstream of the PRV station, but at least five feet from the last point of turbulence. The line should slope downward going away from the valve. The old setpoint signal tap may meet these requirements.

The pilot setpoint signal should be fed directly from a stable compressed air source through a controller that can provide a stable, constant air pressure.

The 10,000 lbs/hr valve controls would be set to open the valve before the larger valve. The small valve will be able to handle the loads until the outside temperature drops below about 40 degrees F (see Figure 2.2-4, p. 2-19). This occurs about 900 hours per year; therefore, the smaller valve will handle the load 90 percent of the year. The larger valve control setpoint should be slightly lower than the smaller valve. The larger valve will only open when the smaller valve cannot handle the load.
